An Investigation on the Relationship of Rainfall, Temperature and Landslides in the Dhauladhar Region of Himachal Pradesh

Abstract: The state of Himachal Pradesh reflects hilly region and is known for pleasing weather at some stage in the yr. It even reviews heavy blizzard in the course of the wintry weather months. The climate of Himachal alters with the change of altitude. Landslides can occur in H.P and mountains during the monsoon season, deforestation, road slicing, terracing, and changes in agricultural output vegetation increased the hazard of geologically young and now not so strong steep slopes in various Himalayan grades at a rapid rate in recent years. In the present study the investigation was conducted on the four-lane NH- 154 Pathankot to Mandi and number of landslides was observed. It was found that Rainfall causes the majority of landslides, according to research. The largest no. of landslides were recorded in winter season in Kangra followed by Joginder Nagar. Dharamshala is more prone to landslides whereas in Post monsoon highest landslides were recorded in Mandi. The present study shows the relationship between rainfall, temperature patterns and landslides. It a

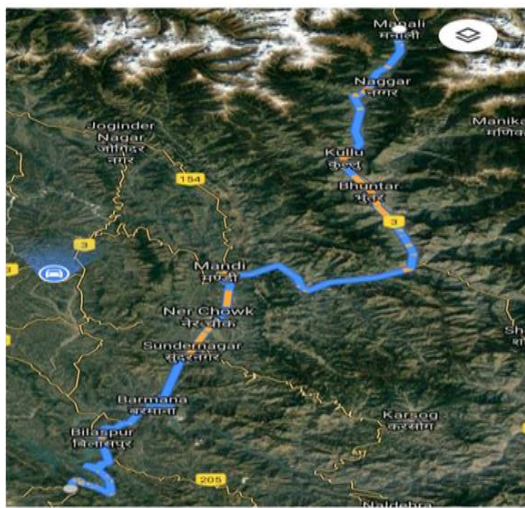
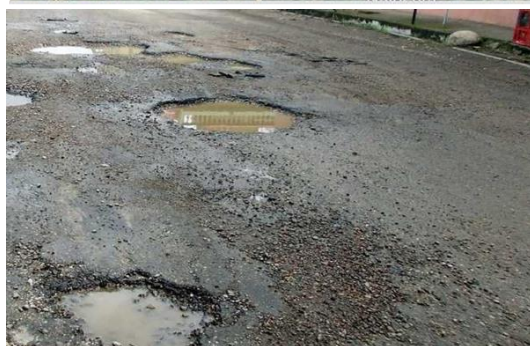
Fig. 1. Pathankot- Mandi Highway (A nightmare for travellers)

During the site visit, the investigation will be conducted on the four-lane NH- 154 Pathankot to Mandi. The road was previously two-lane; however, as the traffic volume on this road

has increased, a four-lane highway is needed. During the tour, a number of landslides was observed, as well as some retaining wall failure. The Joginder nagar highway is a national region that connects Manali, Lahol Spiti, and Leh in Upper Himachal Pradesh. The highway also serves as a connection between Kangra, Kullu, Manali, and Padhar are all connected by this highway. The highway is undergoing reconstruction. The task is being carried out by the National Highway Authority of India, which was formed by the Indian government. The entire highway is being reconstructed as a four-lane highway with better bitumen pavement, modern traffic sign boards, foot paths, tax toll offices, traffic signals, and the addition of new tunnels with the smallest number of road crossings possible. On a bike, the entire stretch of road from Pathankot to Mandi was surveyed, noting the areas where landslides would have taken places. The roadside strata were studied, and failures was addressed with the road site in charge. The highway no. 154 runs for 33.00 kilometres from its intersection with NH-154 in Chakki, Dhar in Punjab, linking Banikhe and Chamba, and concluding at Bharmour in Himachal Pradesh.

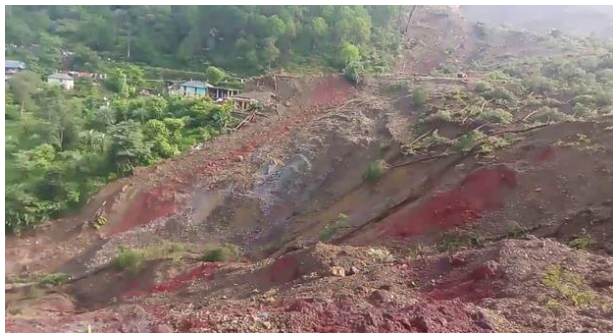
Fig. 3. Landslide in Padhar

sector. The road quality over the last 6-7 kilometres is a little rough, with some potholes. The landslide, which happened around night had damaged the Mandi-Pathankot national route 154 in Padhar, Mandi district, happened near Kotrupi village. Since 1988, this is the third significant tragedy in Himachal Pradesh. Previously, in 1988, 45 bus passengers were buried in a landslide near Matiyana in Shimla district, and in 1994, 42 travelers were trapped in a landslide near Luggar Hati in Kullu district.

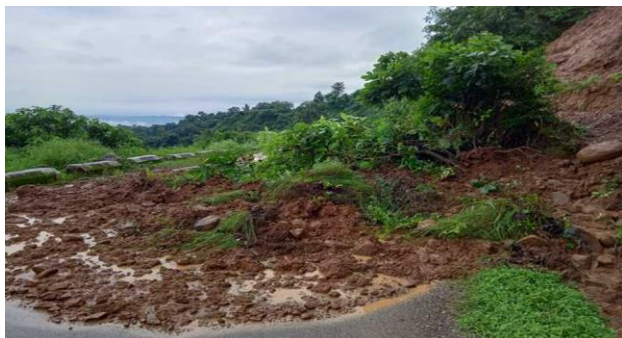
Fig. 4. Landslides in Kangra

Sections of this hilly state, such as Kangra Valley, which sits at the foothills of the Himalayas and sees a lot of landslides every year in various places. During monsoons and high-intensity earthquakes, some portions of District Kangra, including hills and mountains, are prone to landslides. Owing to inappropriate human activity such as forest loss, road cutting, terracing, and soil health crops requiring more intense watering, the vulnerability of the geologically young and not so stable steep slopes in various Dholadhar, Chamba Dhar ranges has been increasing at a rapid rate in recent decade. The Dharamshala region of India's Kangra valley is among the fastest-growing Himalayan cities, and it is prone to landslides virtually all year. The rapid speed of development necessitates landslide susceptibility zonation research to try to provide maps that architects and engineers may utilize to build projects in more secure sites.

The majority of landslides were discovered to occur in a variety of locations, primarily on the uphill side. Landslides are caused by a variety of factors, the most common of which being heavy rainfall.
