Electrical Safety Audit of Central India Institute for Medical Science (CIIMS), Bajaj Nagar, Nagpur

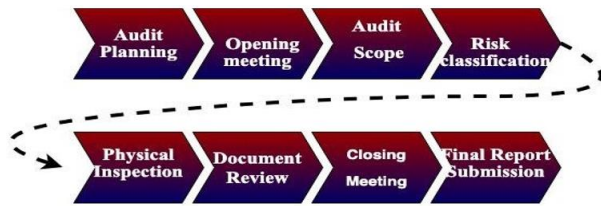
Fig. 1. Methodology

Review of documentation/drawing/records and analysis of collected data and measurements was carried out in comparison

with standards and identification of areas for improvements was done. Recommendation for improvements was suggested for the same. Discussion of these observation & recommendations was carried out with management personnel and by incorporating inputs from them final report was submitted.

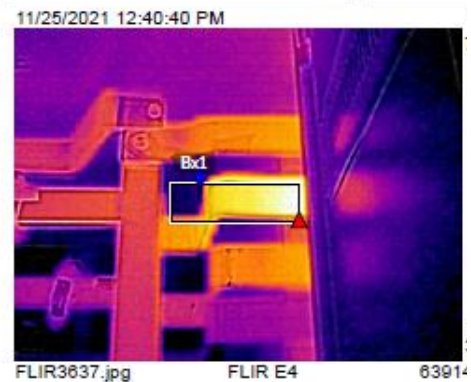
Fig. 2. Sample thermal image-1

Observation: Temperature rise is alarming.
Recommendation: It should be checked and attended immediately.

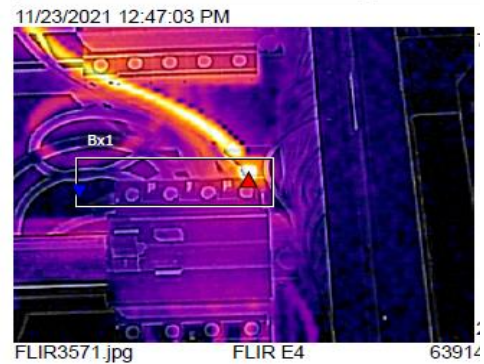
Fig. 3. Sample thermal image-2

Observation: Temperature is found very high.
Recommendation: It should be checked and attended at the earliest opportunity.
