# Integrating Chemical Understanding and Continuous Improvement (Kaizen/PDCA) to Eliminate Sulphuric Acid Pipeline Leakage

**Abstract:** Failure analysis and reliability improvement in a water treatment plant were studied for leak failures [12] occurring due to corrosion and material selection problems of the supply line carrying 98% sulphuric acid [6]. A Kaizen approach with the support of root cause analysis by the Fishbone Diagram, 5 Whys, and FMEA identified the main contributors: material incompatibility, infrequent inspection, and inadequate corrosion monitoring [21]. Utilizing the Kaizen approach [9], an acid-resistant breather with a silica gel desiccant installed at the storage tank vent reduced leakage incidents by approximately 80% within six months.

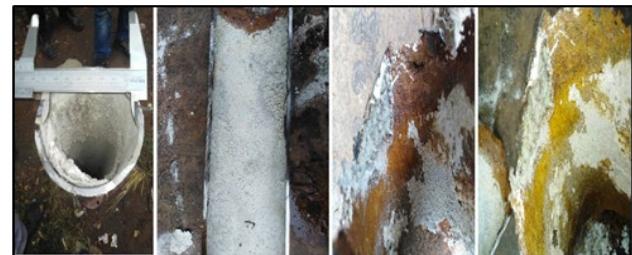
Fig. 2. Acid Pipe line examination: Thickness analysis, Colors test etc.

Iron sulphate sludge buildup in the acid storage tank probably caused partial line blockage and fluctuating flow. Pipe wall thickness was less than 0.010 inch in the leaked area, while other sections measured 0.040 to 0.060 inch, compared to 0.132-inch nominal thickness as the original size. Metallographic examination confirmed typical carbon steel microstructure with no welding or material defects [26].

The two corrosion forms, namely general wall thinning and localized hydrogen grooving, were caused by interconnected mechanisms in the sulphuric acid supply line. General thinning was because of the corrosive action of sulphuric acid in conditions of high flow velocities and turbulence that result in the mechanical removal of the protecting ferrous sulphate film on the carbon steel surface. Localized, sharply defined helical grooves evidenced hydrogen grooving, which occurred during intermittent flow when hydrogen bubbles form under stagnant conditions and dislodge during flow, with consequent damage to the passive film [10], [11].

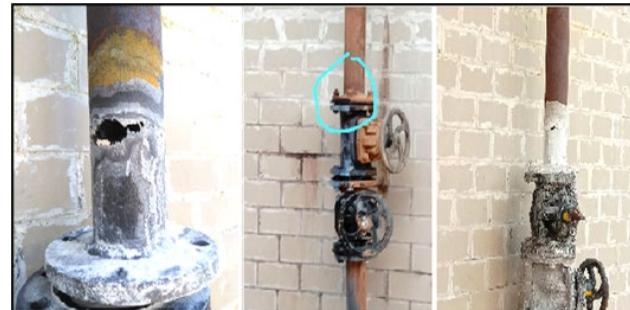
Fig. 4. Leakage points of pipe line

Localized pitting and wall thinning at elbows due to turbulent flow and acid dilution.

The failure was due to ingress of moisture into the carbon steel sulphuric acid line, converting concentrated acid into a dilute, highly corrosive form [13]. This caused severe localized corrosion in the elbow section and subsequent leakage. Contributory factors were improper selection of materials, absence of drying and drainage provision, and humid environmental conditions.

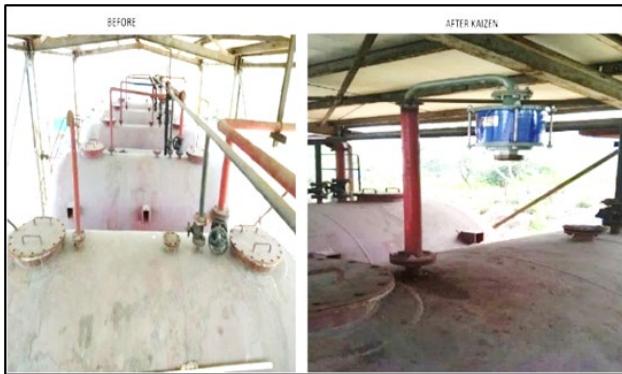
A desiccant-type breather assembly was installed at the vent point of the acid tank [15]. The breather contains moisture-absorbing material (silica gel/molecular sieve) that removes humidity from the incoming air, ensuring only dry air enters the tank during pressure equalization.

**Type:** Industrial-grade desiccant breather with color-change silica gel (blue-to-pink indicator).

**Material of Construction:** Acid-resistant FRP body with PTFE sealing to withstand acidic vapors.

**Mounting:** Installed vertically on the tank top nozzle, with a splash guard to prevent acid mist contact.

Fig. 5. Before and after implementation of solution: Breather located

- When the tank breathes in (during acid withdrawal or temperature drop), air passes through the desiccant bed.
- The desiccant adsorbs water vapor from the incoming air.
- Only dry air enters, preventing moisture contamination of acid.
- When the tank breathes out (during filling or heating), air exits through the same path.

By installing a desiccant breather, the ingress of  $\text{H}_2\text{O}$  (moisture) was physically blocked, preventing acid dilution. As a result, the acid remained >98% concentrated, under which the corrosion rate of carbon steel is negligible (<0.05 mm/year).
