Vibration Reduction through Centrifugal Fan Balancing in Painting Line Manufacturing

Keywords: Exhaust fan centrifugal, Fan, Fan Balancing, Painting booth, Vibration.

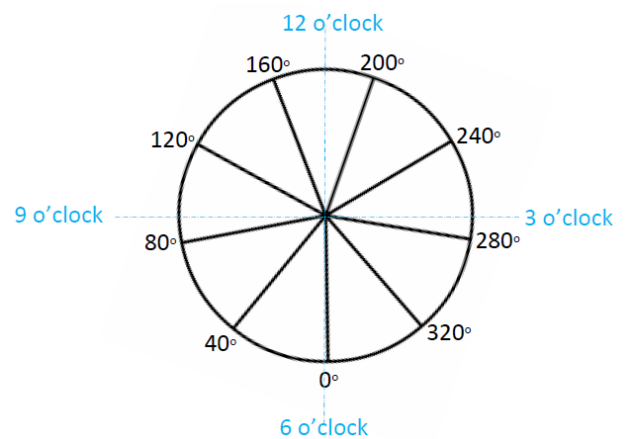
Fig. 2. Impeller divisions for static balancing reference points

impeller was manually rotated and allowed to settle. The spot at 6 o'clock position was identified as the heavy spot and marked as 0° presented in figure 3. The impeller was divided into nine 40° intervals, corresponding to the 9 blades. At 12 o'clock was designated for trial weights as it is directly opposite the heavy spot. A 5g trial weight was mounted at 12 o'clock. The fan was manually rotated to balance the high sport. Subsequently, 17 g and 20 g were tested. The 20 g weight gave the best settling behavior, effectively offsetting the heavy spot. The fan was assembled back and operated with the 20 g trial weight at 12 o'clock and vibration measured and recorded.

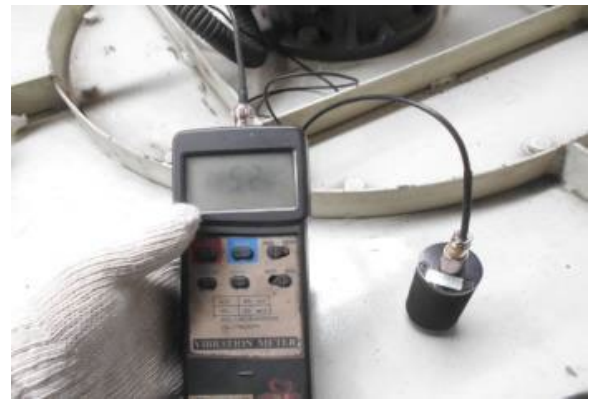
At the beginning of the analysis, the fan exhibited extremely high vibration levels at all three measurement points, indicating critical operational conditions. These readings significantly exceeded the ISO 10816 acceptable limits for industrial machinery, especially considering the rigid fan mounting.

Fig. 3c. Initial vibration check (axial)

Measurement Point	Horizontal (mm/s)	Vertical (mm/s)	Axial (mm/s)
Exhaust Fan 1	4.60	7.50	5.20

This severe condition required an immediate and thorough mechanical inspection and alignment and balancing intervention on the exhaust fan system. The vibration values were presented in table 1.

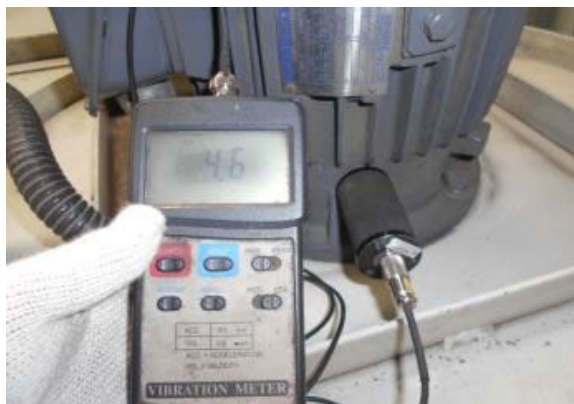
Fig. 3a. Initial vibration check (horizontal)

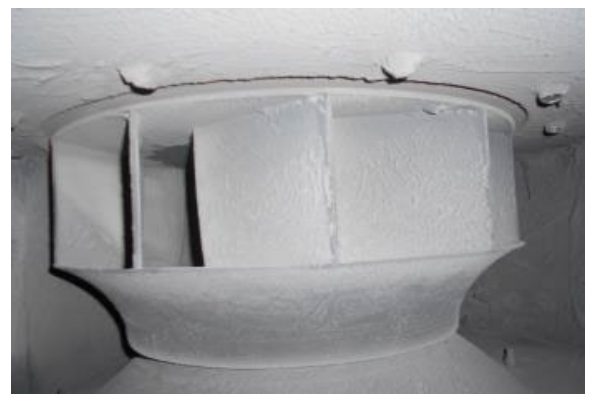
Fig. 4. Impeller before cleaning

The procedure for reducing fan vibration begins with dismantling the exhaust fan, followed by cleaning the impeller using a scraper and wire brush. the process can be seen in the Fig. 4.

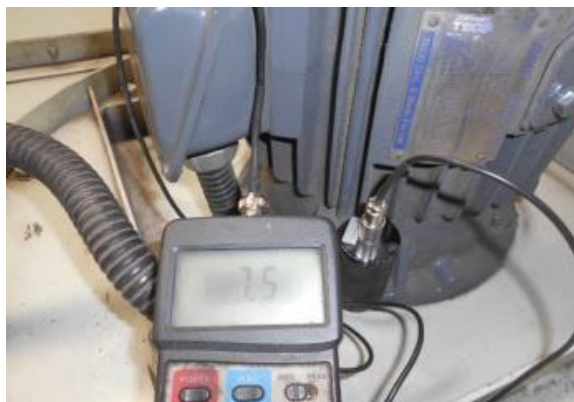
Fig. 3b. Initial vibration check (vertical)

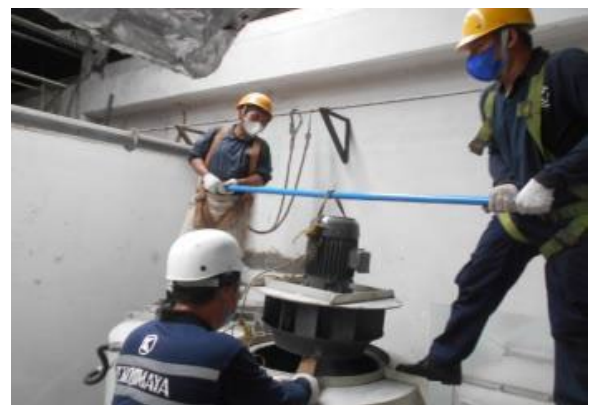
Fig. 4. Dismantling fan

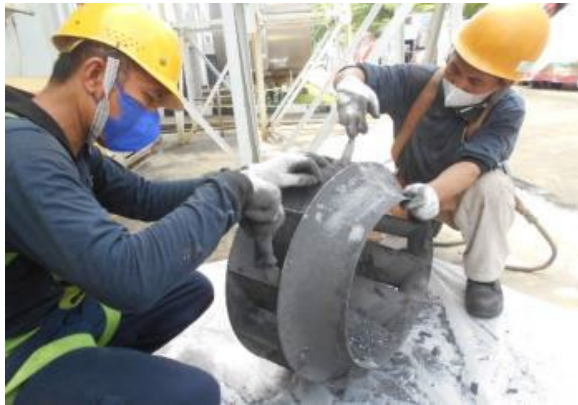
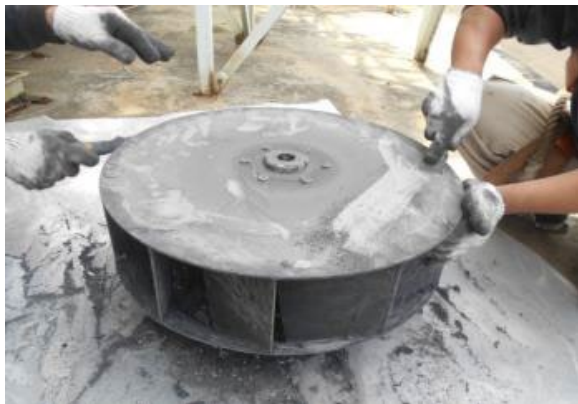
Fig. 5a. Cleaning impeller

Fig. 5b. Cleaning impeller

Surface Preparation with the use of wire brush to remove contaminants and buildup of materials from the impeller to ensure accurate balancing and secure placement of weights. The

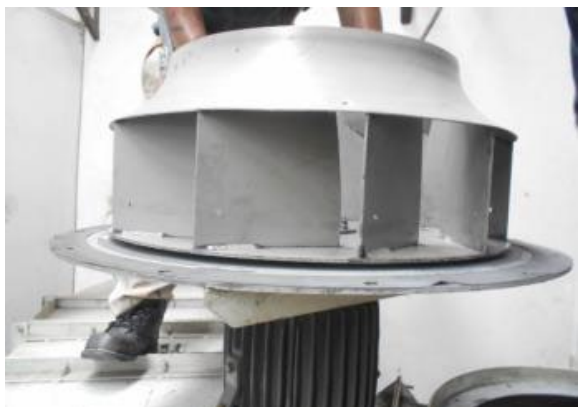
Fig. 5c. Impeller after cleaning

Next procedure, with surface preparation and cleaning then manually rotating the impeller to determine the heavy spot which was marked as point 0° while Opposite this, was 180° identified as the light spot and therefore the most appropriate location for placing a trial counterweight.

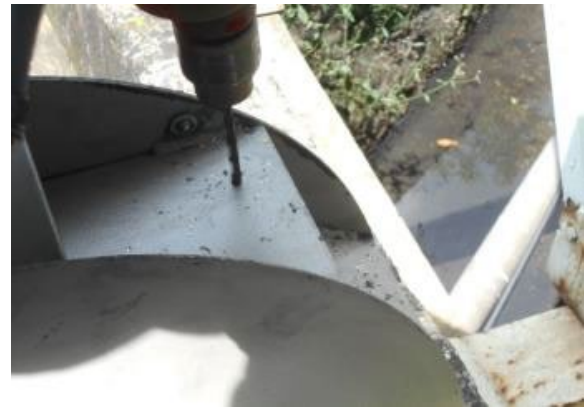
Fig. 6. Drill process

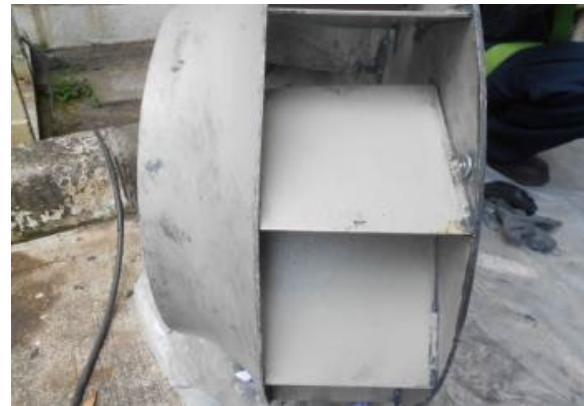
Fig. 7. Apply 5g weight

A sequence of trial weights was tested for static correction. 5 g weight at 12 o' clock showed minimal effect. 17 g improved the settling balance but not satisfactorily. 20 g weight demonstrated the most significant correction during manual settling. The 20 g trial weight was mounted at 12 o' clock and the fan were reassembled for operational testing.

Based on the positive results of the 5g weight test, the weight of the ring significantly impacts the impeller's rotational balance. The vibration test results are shown in the table 2.

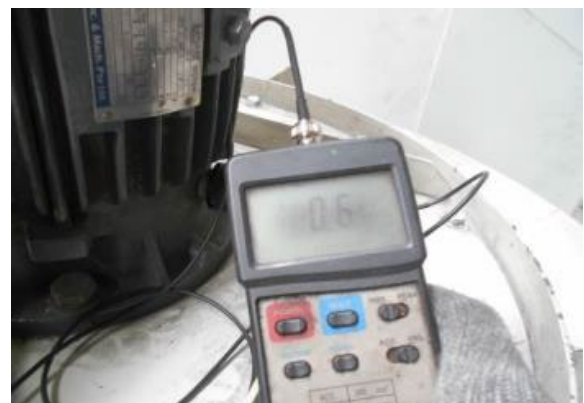
Measurement Point	Horizontal (mm/s)	Vertical (mm/s)	Axial (mm/s)
Exhaust Fan 1	0.60	1.90	2.80

Fig. 7a. Final vibration check (horizontal)

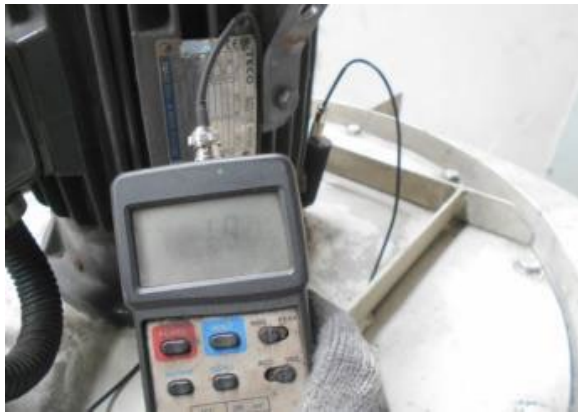
Fig. 7b. Final vibration check (vertical)

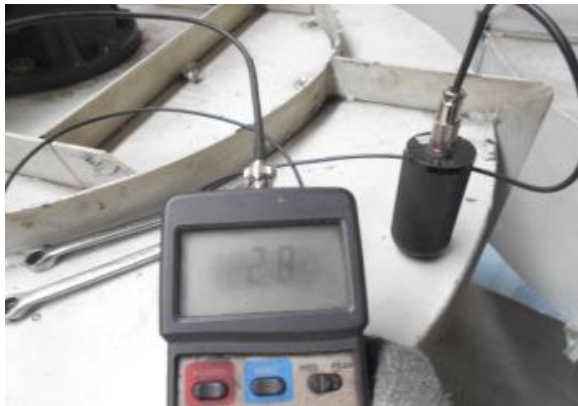
Fig. 7c. Final vibration check (axial)
